SOUTH ACCESS TO THE GOLDEN GATE BRIDGE  
**DOYLE DRIVE**

## **Structural Condition and Replacement Memorandum**

**April 2, 2008**

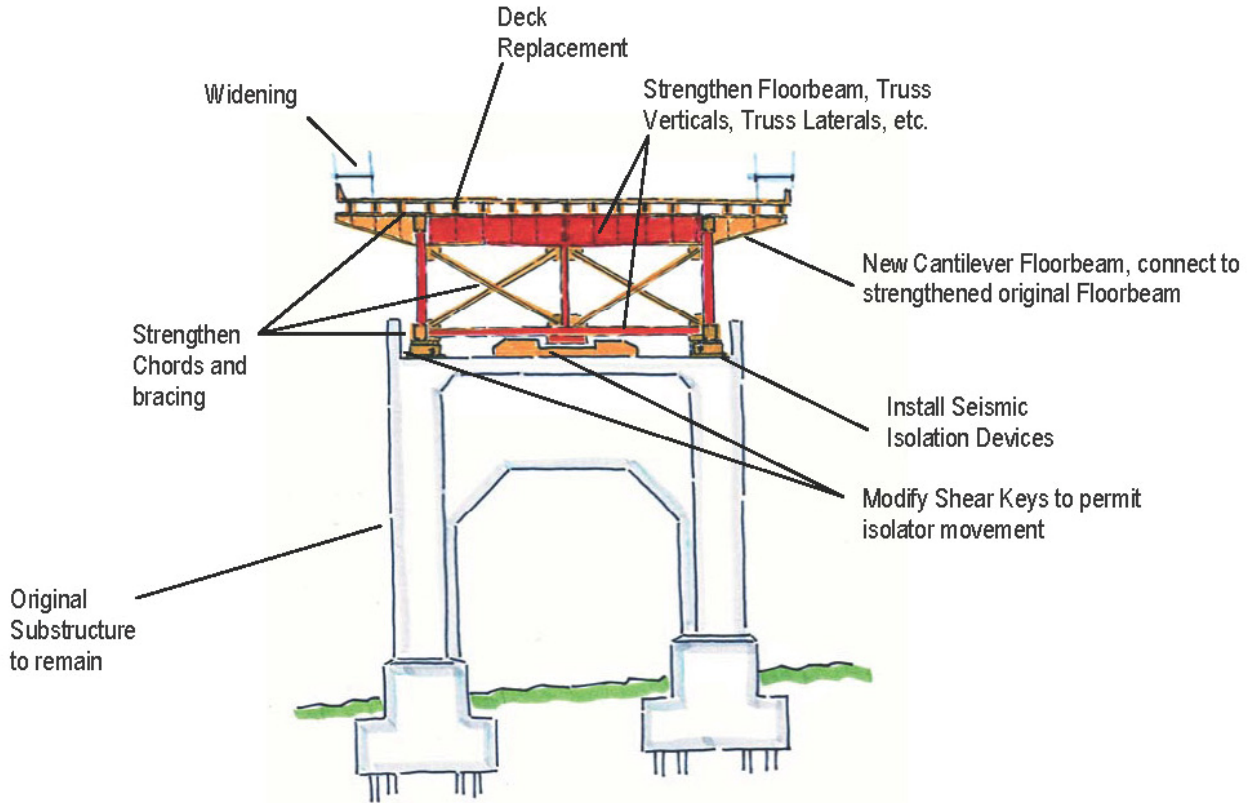
**Figure 2-2. Rehabilitation of the Presidio Viaduct Determined to be Unfeasible**

The steel stringer (a.k.a. steel beam) approaches of the Presidio Viaduct, which have no transverse floorbeam, would require widening of the substructure in order to support the additional deck width.

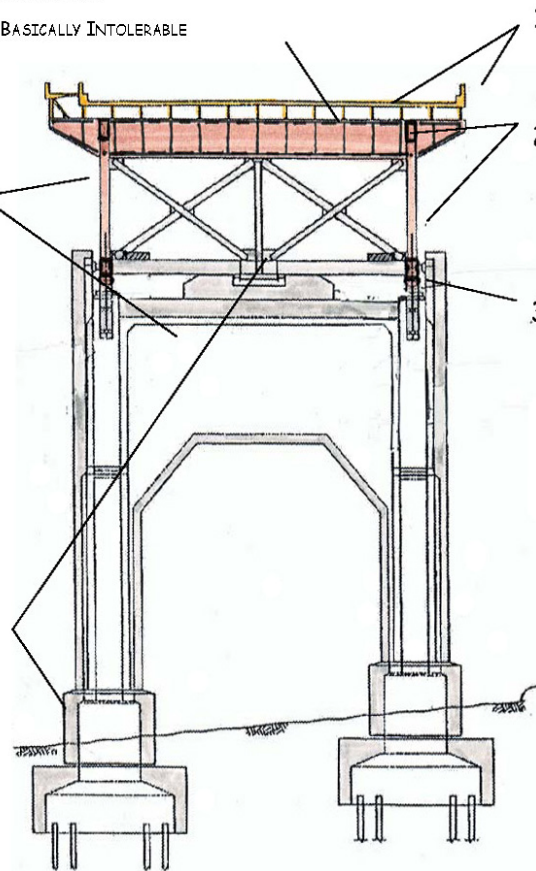
**Presidio Viaduct-Typical Section**

Deck Condition: CRITICAL CONDITION

Structural Evaluation: BASICALLY INTOLERABLE

Superstructure:  
CRITICAL CONDITION

Substructure:  
SATISFACTORY CONDITION

Seismic performance is a function of the current level of section loss in the lateral bracing of the truss and the 1998 Seismic Retrofit (Grey)

1. Reinforced concrete bridge deck is original and is delaminated from steel deck stringer at the expansion joints and is pounding. Barrier and light standards are in an advanced state of deterioration.
2. Truss is currently undergoing repainting and minor repairs, including many as-needed repairs to steel members. Thus far significant loss of section was observed in the lateral bracing system not previously upgraded, enough to raise concerns about seismic performance.
3. Bottom chord of truss is a fracture critical member requiring special inspection.

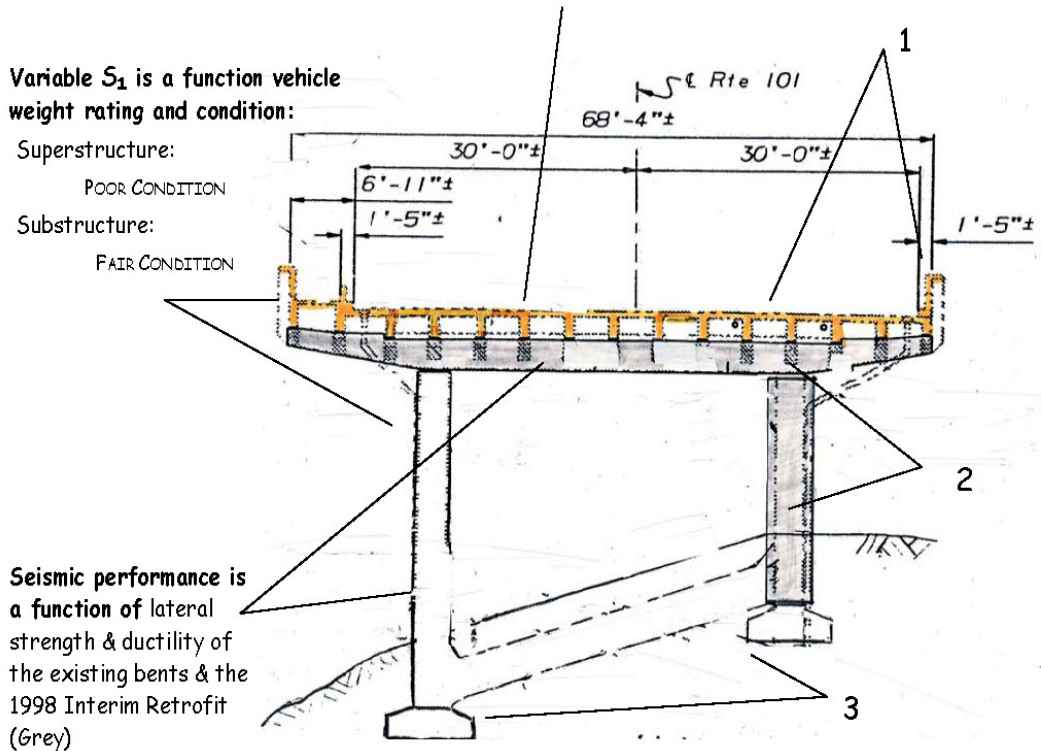
**Marina Viaduct-Typical Section**

Deck Condition: POOR CONDITION

Structural Evaluation: MEETS MINIMUM TOLERABLE LIMITS TO BE LEFT IN PLACE AS IS

Load Rating: 24.5 T METRIC (VS. STD OF 32.4 T METRIC)

1. Reinforced concrete bridge deck is original and is integral with the deck stringer forming a "T" beam. An overlay was placed in 1992 and is at the end of its useful life. Leaks in the expansion joints and salt air have deteriorated the concrete. Barrier and light standards are also in an advanced state of deterioration
2. The 1998 Interim Retrofit jacketed short columns vulnerable to shear failure and added seat extenders under the "drop-in" bridge deck spans. Retrofit increased strength of the bents to handle a 0.4 g seismic event that has 5% probability of occurrence in 10 years. Expected Seismic Performance is judged to be better than the un-reinforced masonry building stock in the City but less than the level for Ordinary Highway Bridges.
3. Original foundations, supported on lightly reinforced concrete piles and timber piles are located in a Liquefaction Hazard Area

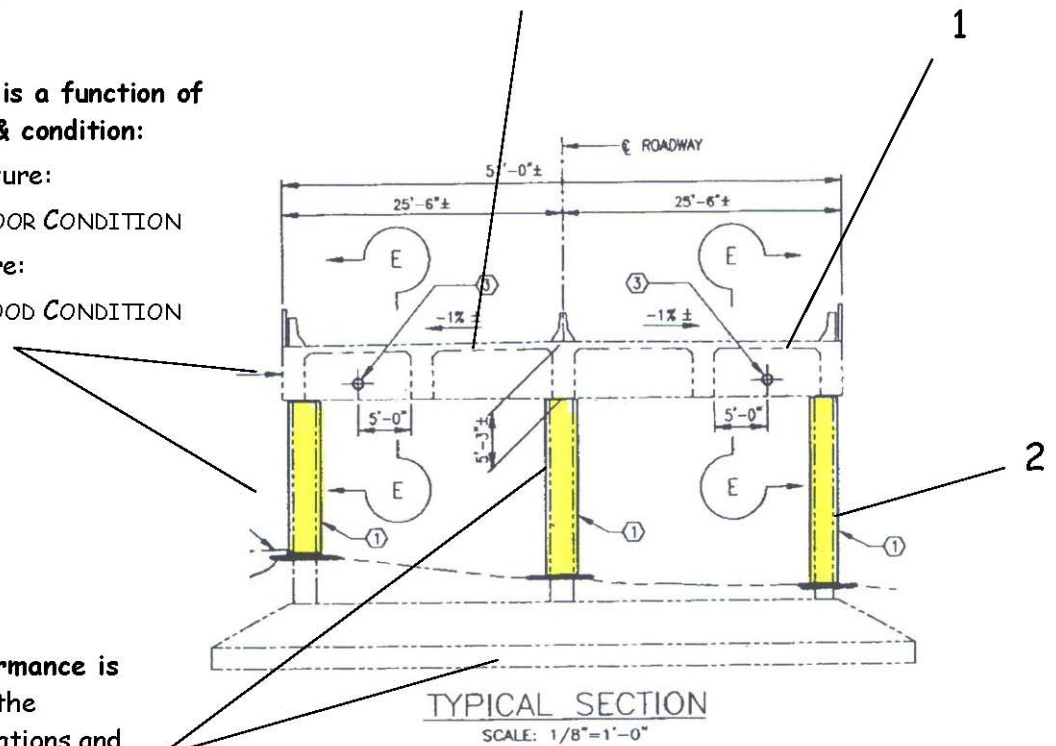
### Ruckman/Story UC-Typical Section

Deck Condition: POOR CONDITION

Structural Evaluation: MEETS MINIMUM TOLERABLE LIMITS TO BE LEFT IN PLACE AS IS

Load Rating: 30.8 T METRIC (VS. STD OF 32.4 T METRIC)

POOR CONDITION

GOOD CONDITION

Seismic performance is a function of the existing foundations and the 1995 Seismic Retrofit (Yellow)

1. Reinforced concrete bridge deck is original and is integral with the deck stringer forming a "T" beam. The deck is bare and it is at the end of its useful life. Leaks in the expansion joints and salt air have deteriorated the concrete. Barrier and light standards are also in an advanced state of deterioration
2. The 1995 Seismic Retrofit jacketed columns and added seat extenders at the abutments. Expected Seismic Performance is judged to be that expected for Ordinary Highway Bridges.

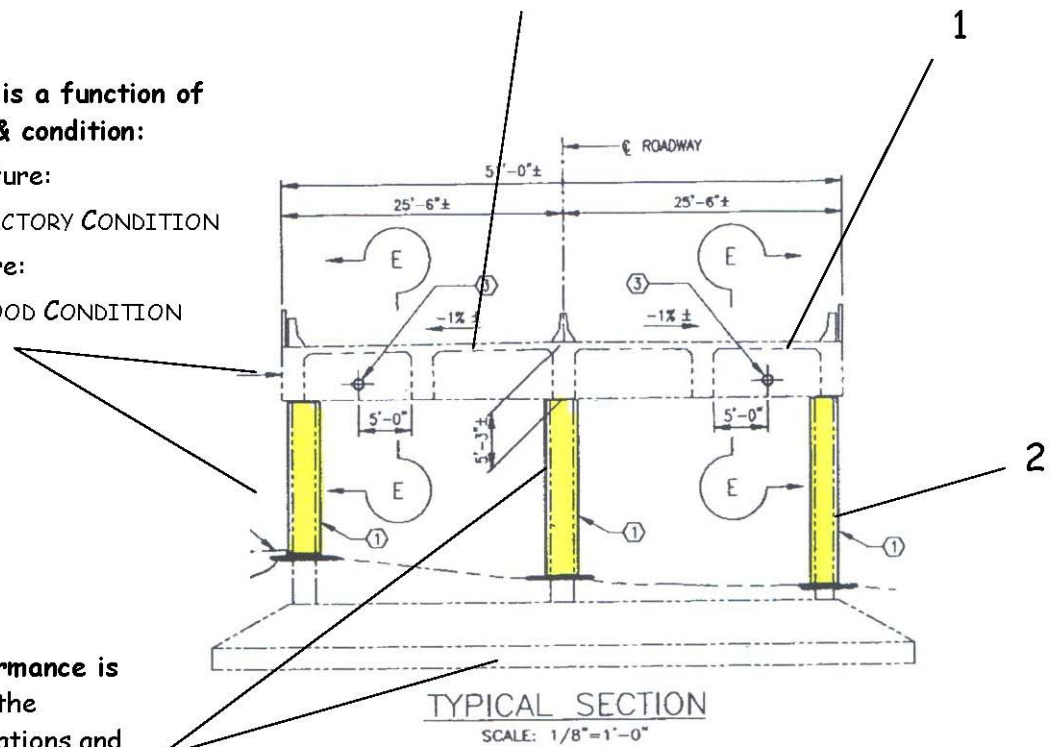
**Kobbe UC-Typical Section**

Deck Condition: *SERIOUS CONDITION*

Structural Evaluation: *SATISFACTORY CONDITION*

*SATISFACTORY CONDITION*

*GOOD CONDITION*

Seismic performance is a function of the existing foundations and the 1995 Seismic Retrofit (Yellow)

1. Reinforced concrete bridge deck is original and is integral with the deck stringer forming a "T" beam. The deck is bare and it is at the end of its useful life. Leaks in the expansion joints and salt air have deteriorated the concrete. Barrier and light standards are also in an advanced state of deterioration
2. The 1995 Seismic Retrofit jacketed columns and added seat extenders at the abutments. Expected Seismic Performance is judged to be that expected for Ordinary Highway Bridges.
