SOUTH ACCESS TO THE GOLDEN GATE BRIDGE  
**DOYLE DRIVE**

## **Structural Condition and Replacement Memorandum**

**April 2, 2008**

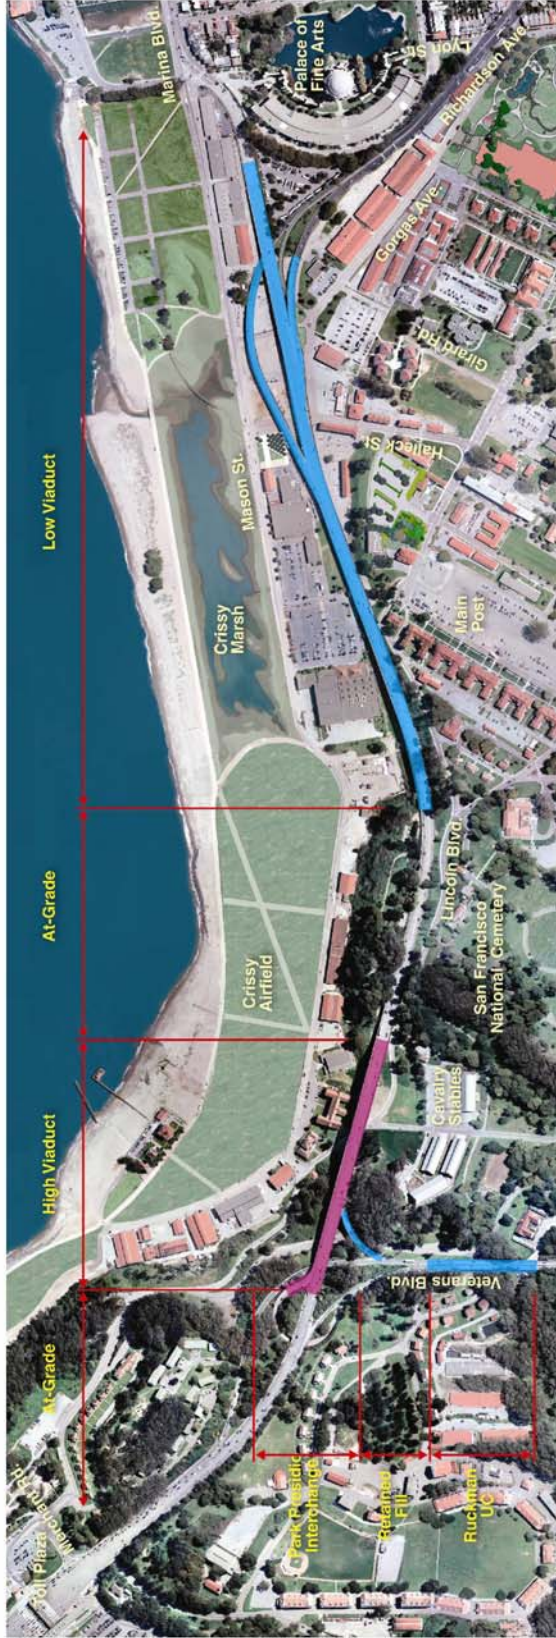
Figure 2-1. Doyle Drive Available Structural Improvement Strategies

The remaining structures that make up the bulk of Doyle Drive were built in a manner that prohibits the rehabilitation and preservation techniques of Strategy-1 and the structures would need to be replaced as addressed in Strategy-2. This is discussed in more detail below. [See Figure 2-1, for locations where strategies apply].

Reliable execution of this long term rehabilitation construction would require the use of temporary supports and construction of a detour structure. The rehabilitation concept for the truss spans, determined to be infeasible, is illustrated in Figure 2-1.

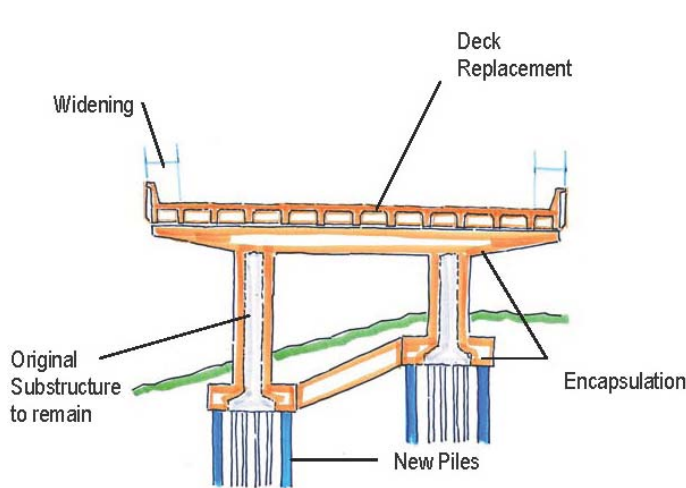
**Figure 2-3. Deck Replacement & Substructure Encapsulation in Kind**

**Marina Viaduct Rehabilitation Concepts Determined to have Unreasonable Cost and Limited Benefits are illustrated in Figures 2-3 & 2-4.**

Detours can be minimized by first installing temporary supports followed by substructure encapsulation that creates new load bearing cap-beams, columns and foundations. Installation of the temporary supports and the encapsulation would take place while the viaduct remains in service. Upon completion of this work the deck replacement operation would commence. Deck segments would be progressively replaced using a combination of regular night time as well as several extended weekend closures. This space saving and schedule trimming approach would require many temporary supports and lifting of large pieces. Alternately, a simplified approach using detour structures can be pursued. The detours would carry traffic and clear the space needed to conventionally construct an entirely new viaduct that resembled the above ground “look” of the original viaduct. Both concepts were found to have similar costs.
